LANARK COUNTY

Public Works Departmental Review

Final Report

January 2023 – 22-4587

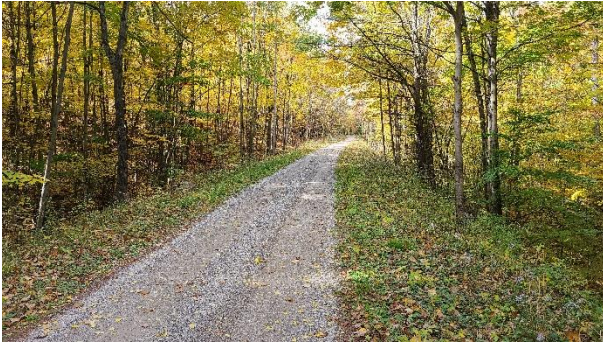
Trail Cross Section

Typical cross section of the Tay-Havelock Trail featuring a stone dust surface with maintained grassed shoulders. The multi-use trail section is generally in Good condition exhibiting light rutting, localized medium to severe rutting, light potholes, and erosion.

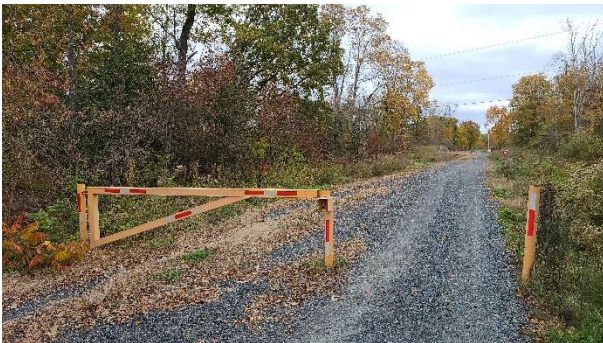
Gates

Trail gates allowing trail users to pass through but blocking passage of vehicles. The gate reflective tape and paint that has faded due to exposure and slight rusting was evidenced. All gates were given a condition rating of Fair.

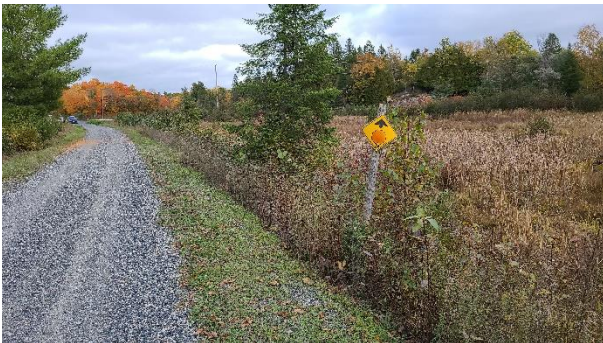
Signage

Stop Ahead warning sign, typically found in advance of each trail crossing. This sign exhibits slight discolouration due to exposure. A rating of Good was assigned. All signs were found to be generally in Good condition.

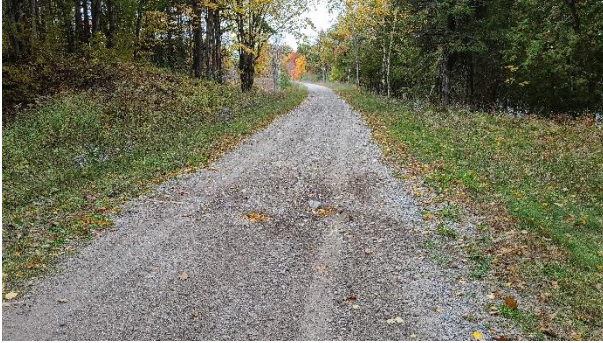
Rutting and Potholes

Trail platform exhibits moderate rutting and significant potholes. This deterioration was localized to a small area. A rating of Poor was assigned.

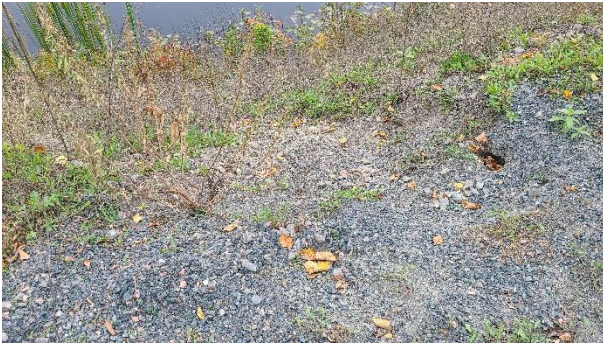
Embankment Erosion

Embankment exhibiting significant erosion which appears to be accelerated due to turtle nesting activity when compared to adjacent stretches of trail. A rating of Poor was assigned.

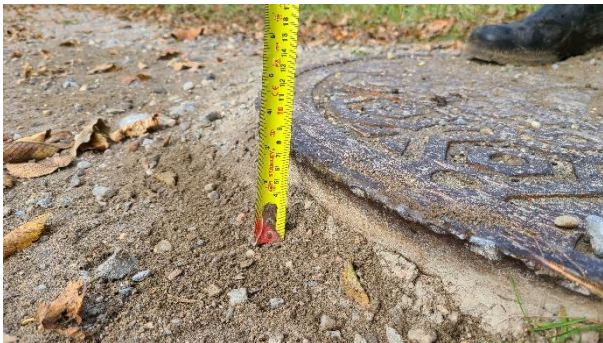
Raised Maintenance Hole

Bell Canada maintenance hole located within the trail. The maintenance hole protruded approximately 80 mm above grade creating a hazard to trail users. The trail was given a rating of Poor in this localized area.

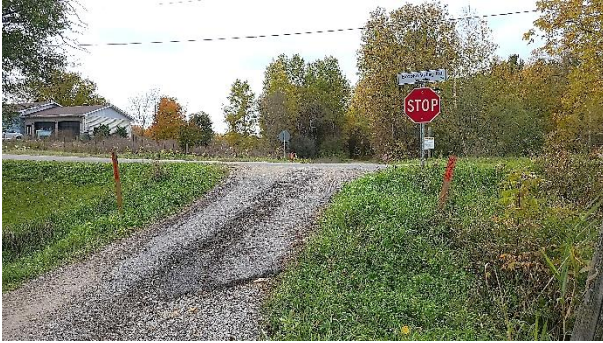
Asphalt Apron

Brooke Valley Road trail crossing featuring an asphalt apron. The asphalt apron exhibited significant deterioration and raveling of material. A rating of Poor was assigned.

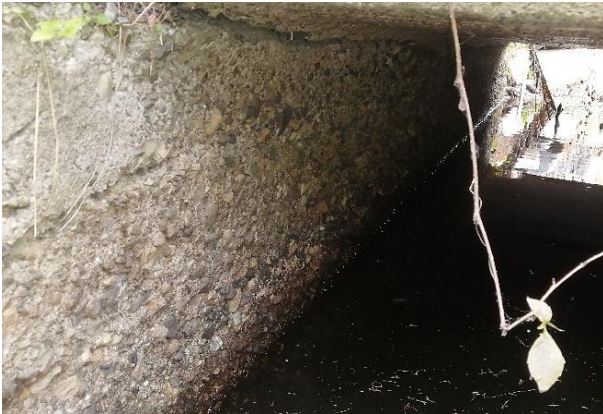
Non-Structural Culverts

Culvert C14 concrete barrel wall. The barrel exhibited medium to severe scaling, disintegrations and ice damage. This non-structural culvert was rated in Poor condition

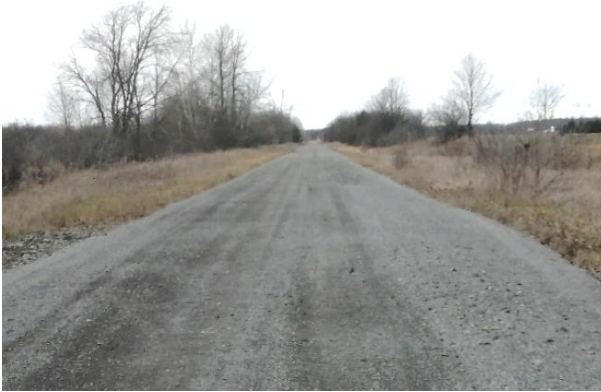
Trail Cross Section

Typical cross section of the Tay-Havelock Trail featuring a stone dust and granular surface. The multi-use trail section is generally in Fair to Poor condition exhibiting light to medium rutting.

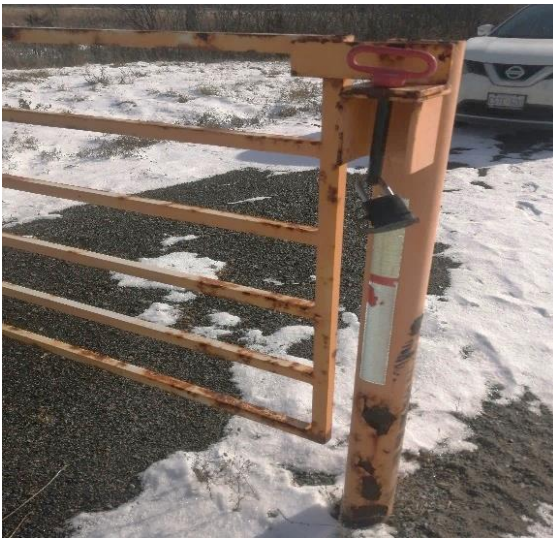
Gates

Trail gates allowing trail users to pass through but blocking passage of vehicles. The gate reflective tape has faded due to exposure, paint has started to peel, and light corrosion was evidenced. All gates were given a condition rating of Fair.

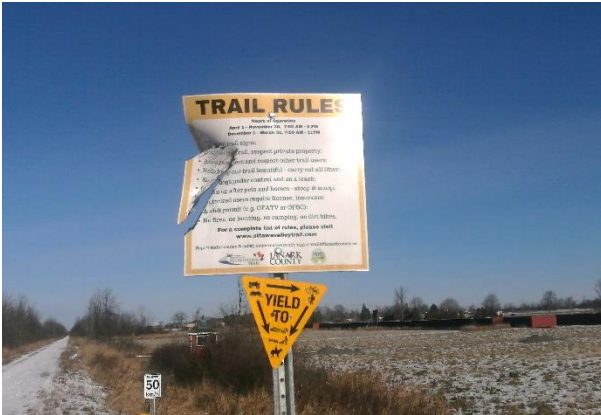
Signage

Trail rules sign exhibited severe damage. A rating of Poor was assigned. All signs were found to range in condition from Poor to Good. Several Stop Ahead and Stop signs were missing and should be replaced. These are highlighted in the condition comments and recommendations.

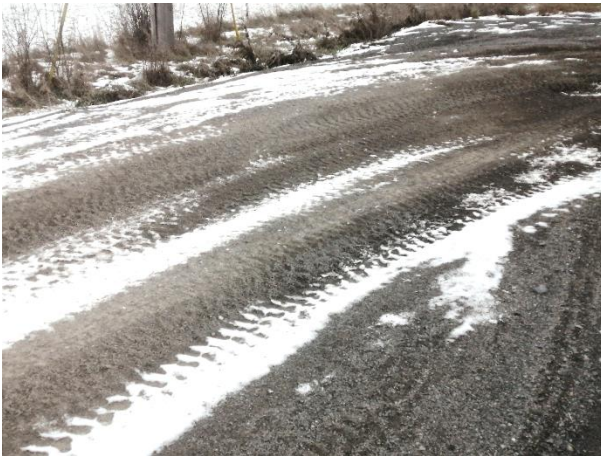
Rutting and Potholes

Trail platform exhibited severe rutting and significant potholes. This deterioration was localized to a small area. A rating of Poor was assigned.

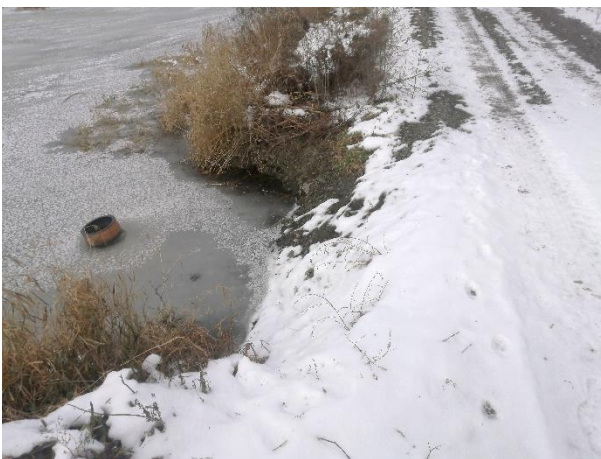
Embankment Erosion

Embankment exhibiting significant erosion which appears to be accelerated due trail width and standing water on either side of the trail. A rating of Poor was assigned.

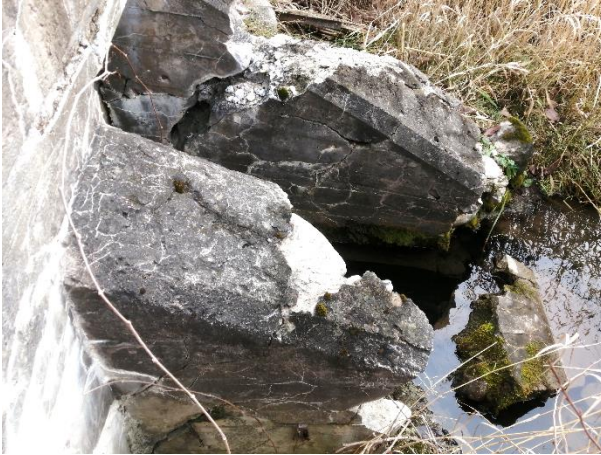
Non-Structural Culverts

The culvert shown exhibits severe delaminations, displaced wingwalls, severe spalling and efflorescence throughout. This non-structural culvert was rated in poor condition.
